IMPACT RESISTANCE OF
COMPOSITE FAN BLADES

E. J. PREMONT
K. R. STUBENRAUCH

PRATT & WHITNEY AIRCRAFT
DIVISION OF UNITED AIRCRAFT CORPORATION

1. Report No. NASA CR-134515	2. Government Accession No.	3. Recipient's Catalog No.	
4. Title and Subtitle Impact Resistance of Composite Fan Blades Final Report		5. Report Date May 1973

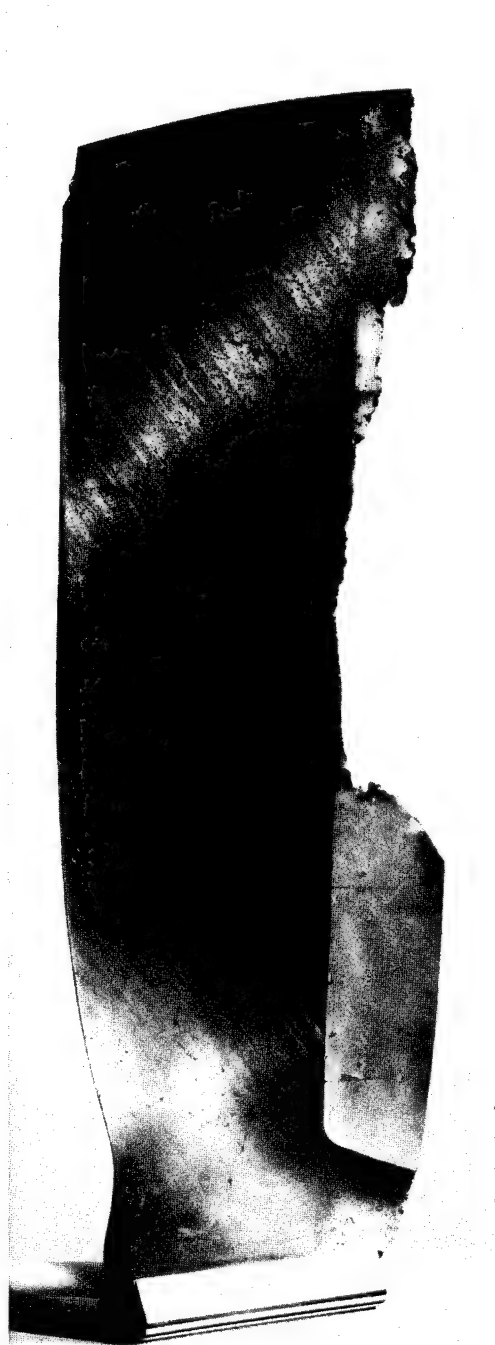
Figure 31 Graphite/Epoxy Blade C-2 Following Two Impacts with 320g Gelatin Ball

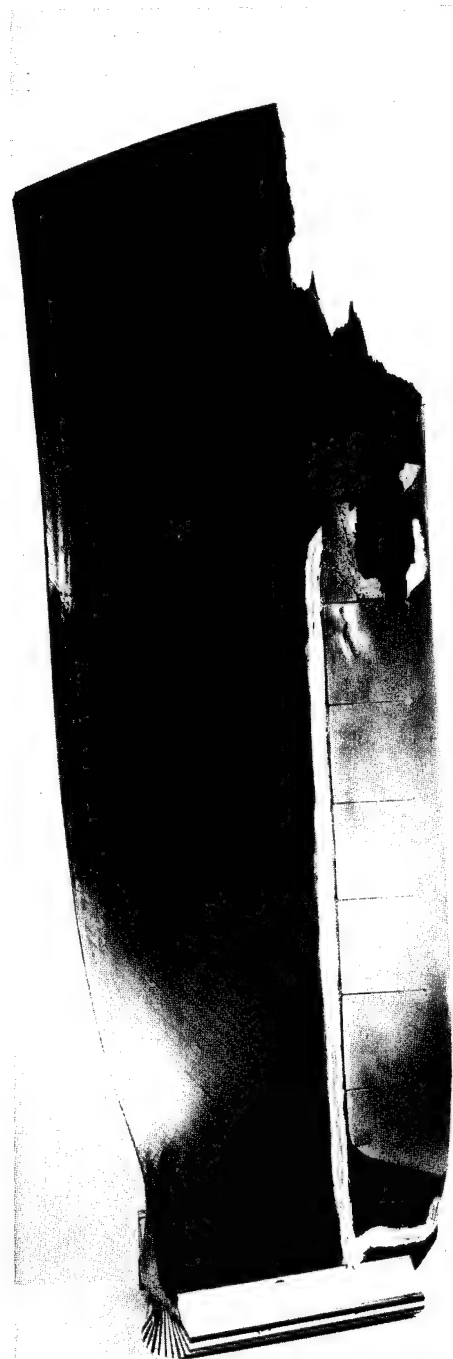
Figure 37 Boron/Epoxy Blade B-3 Following Impact with 165g Gelatin Ball

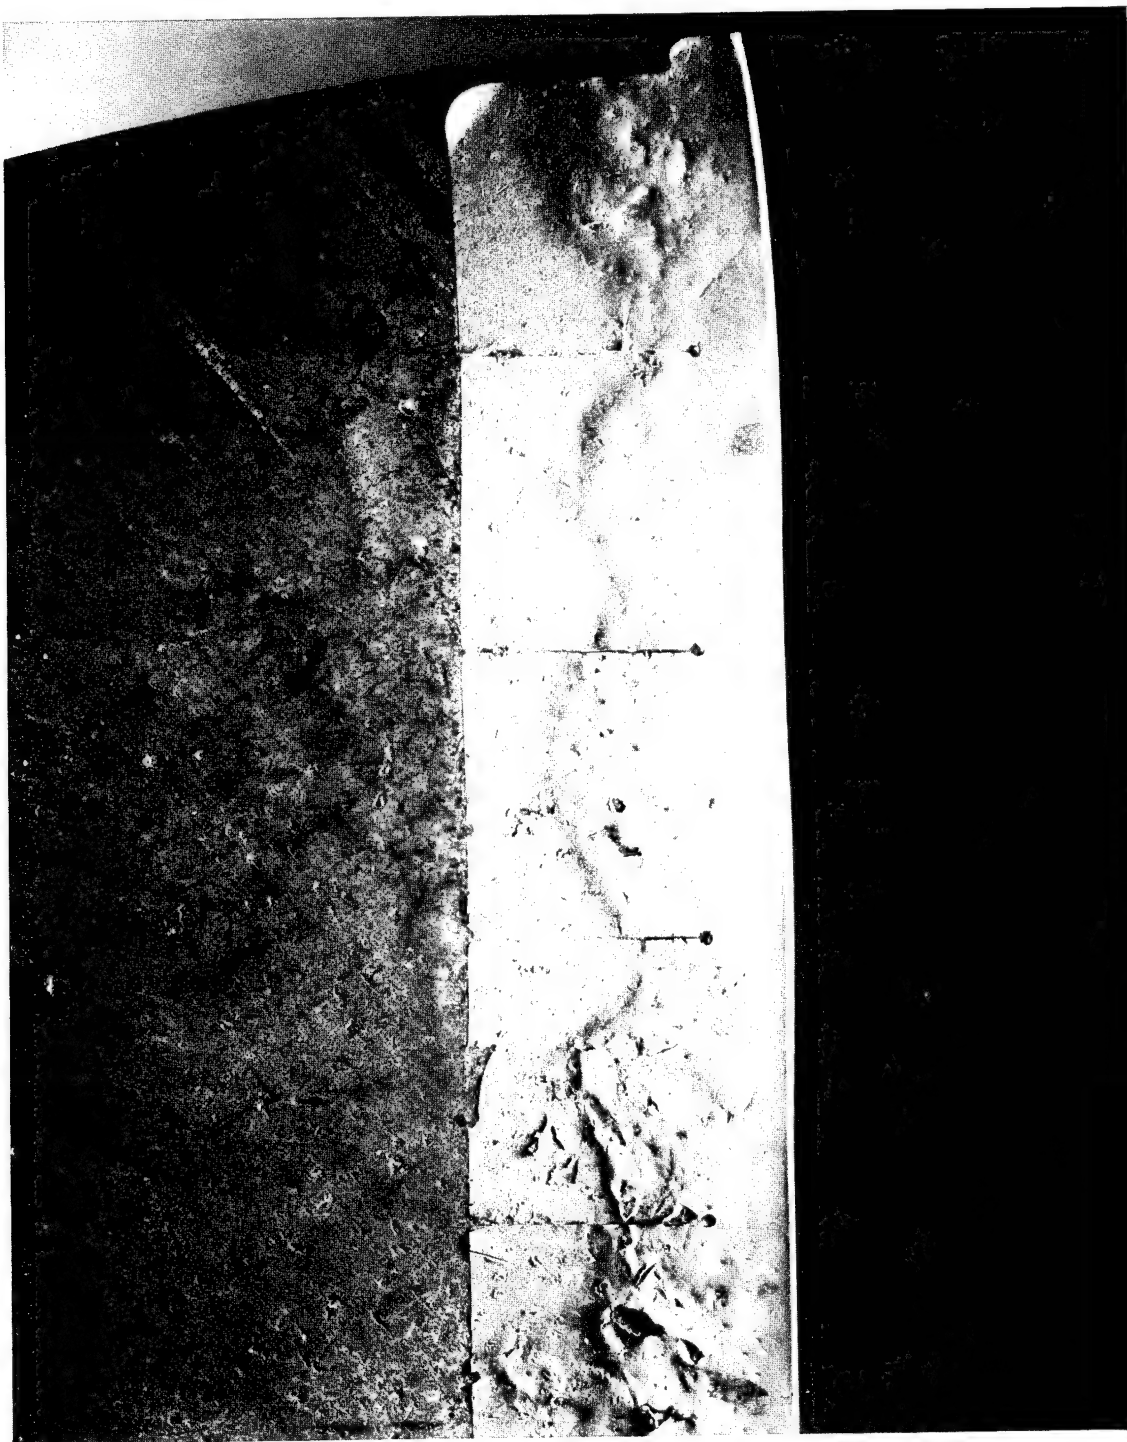
The gravel impact results on blade B-4 are shown in Figures 47 and 48. No ultrasonic indications were found after testing. Damage at the leading edge is negligible, even though the high-speed movies show that impacts did occur at this location. However, the concave side sheath, aft of the leading edge, was nicked, gouged, and unbounded, as pictured in Figure 49. The gravel apparently strikes the sheath causing compressive stresses on the sheath exterior surface. The stress differential within the sheath is great enough to break the sheath-to-blade bond and then lift the sheath from the surface of the blade. Therefore it is concluded that with a better bond between sheath and blade, the leading edge sheath could offer satisfactory protection from small amounts of gravel ingestion.

Figure 49 Boron/Epoxy Blade B-4 Following Impact with Gravel
